**EXPERIMENTAL MAINTENANCE PAINTING
OF I-65 IN LOUISVILLE
FEDERAL AID RESEARCH TASK NO. 108**

Research Report
KTC-02-25/FR108-01-1F

October 2002

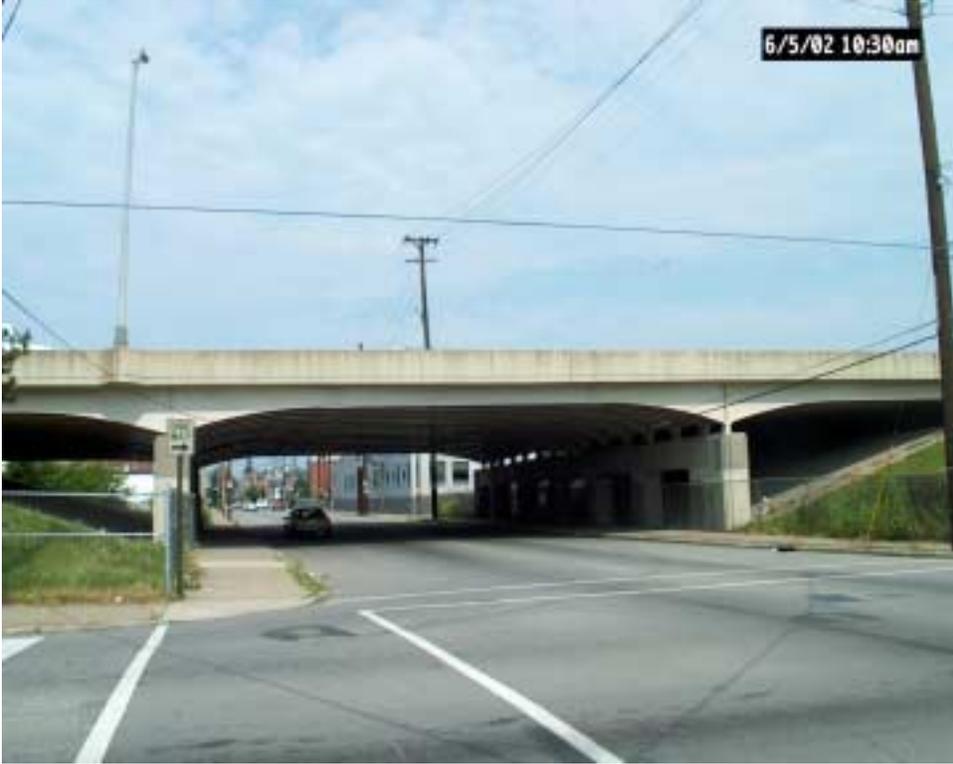
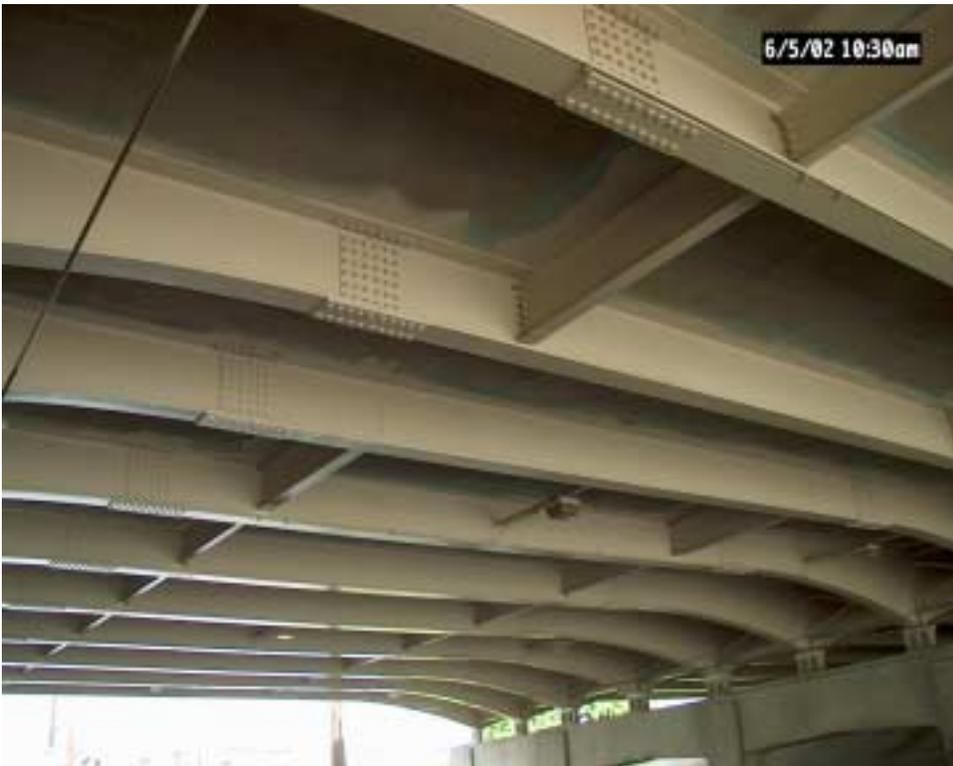
A final inspection was completed on September 28, 2001. The inspection revealed that touch up work was needed in areas where rigging had been placed. Also, areas having holidays and light spots in the finish coat required sanding and re-application of finish coat to the proper DFT. The work area was to be cleaned and all debris and waste removed from site. Personnel from KYTC Central Office Division of Construction and District 5, the Kentucky Transportation Center, and the contractor were present for that final inspection.

Figure 49. View of bridge at Breckinridge Street, between 1st and Brook after painting.

Figure 50. Girders on bridge at Breckinridge Street, between 1st and Brook after painting.

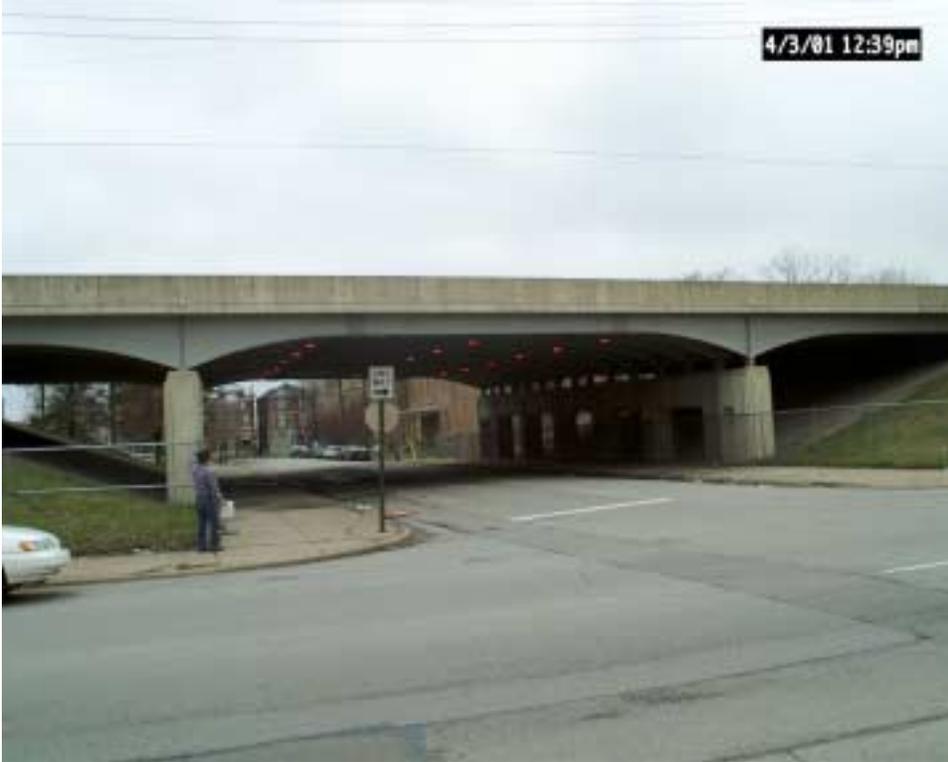
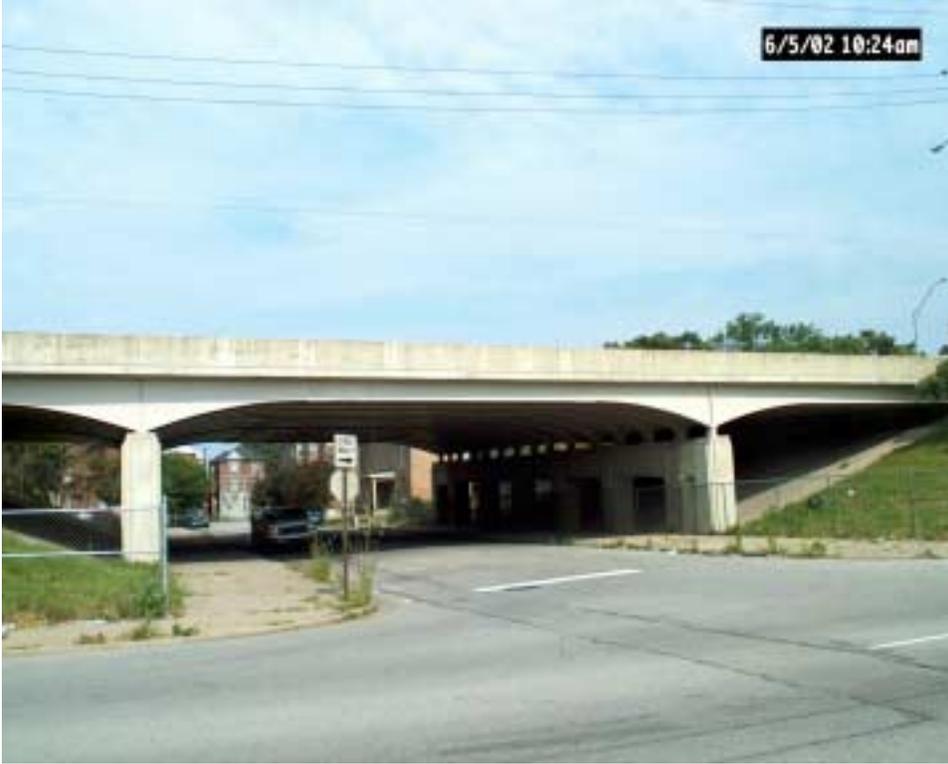
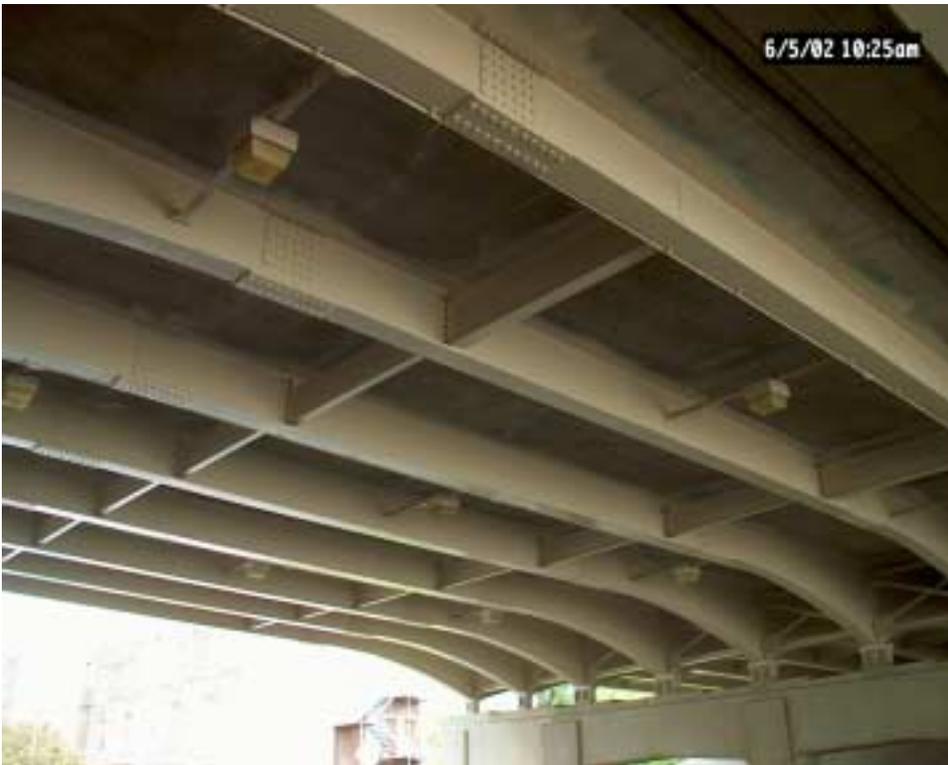
A final inspection was completed on September 28, 2001. The bridge was found to be within conformance to the **Standard Specifications and Special Notes** of this project. Stenciling of the appropriate information is also needed. The work area was to be cleaned and all debris and waste removed from site. Personnel from KYTC Central Office Division of Construction and District 5, the Kentucky Transportation Center, and the contractor were present for that final inspection.

Figure 51. Bridge at Caldwell Street, between 1st and Brook before painting.

Figure 52. Girders at Caldwell Street Bridge, between 1st and Brook before painting.

Figure 53. Bridge at Caldwell Street, between 1st and Brook after painting.

Figure 54. Girders on bridge at Caldwell Street, between 1st and Brook after painting.

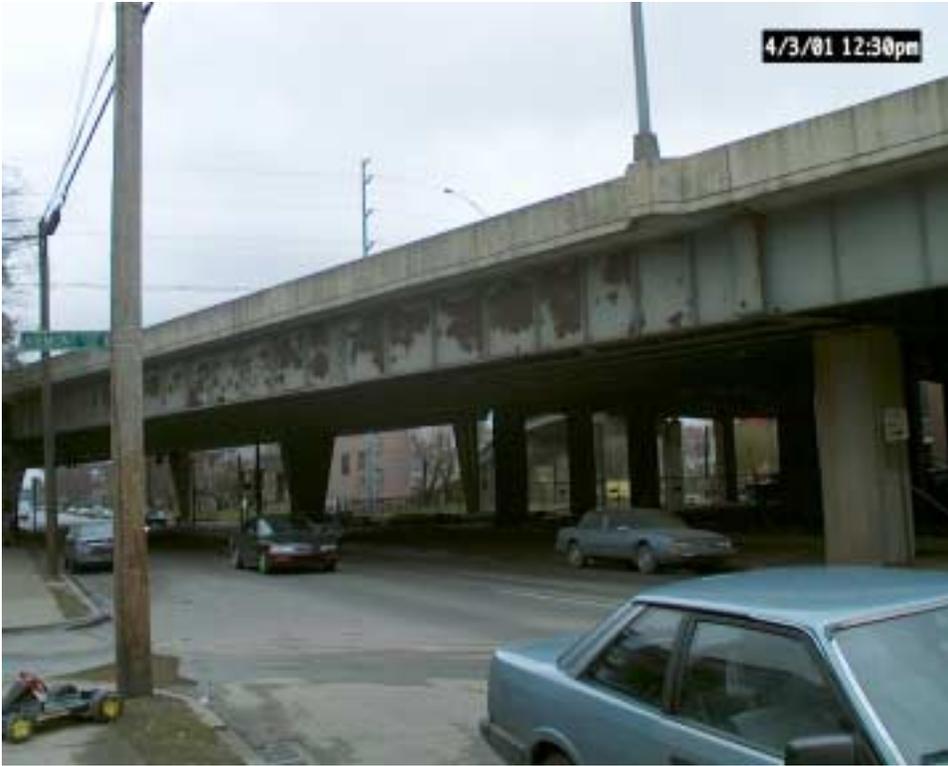
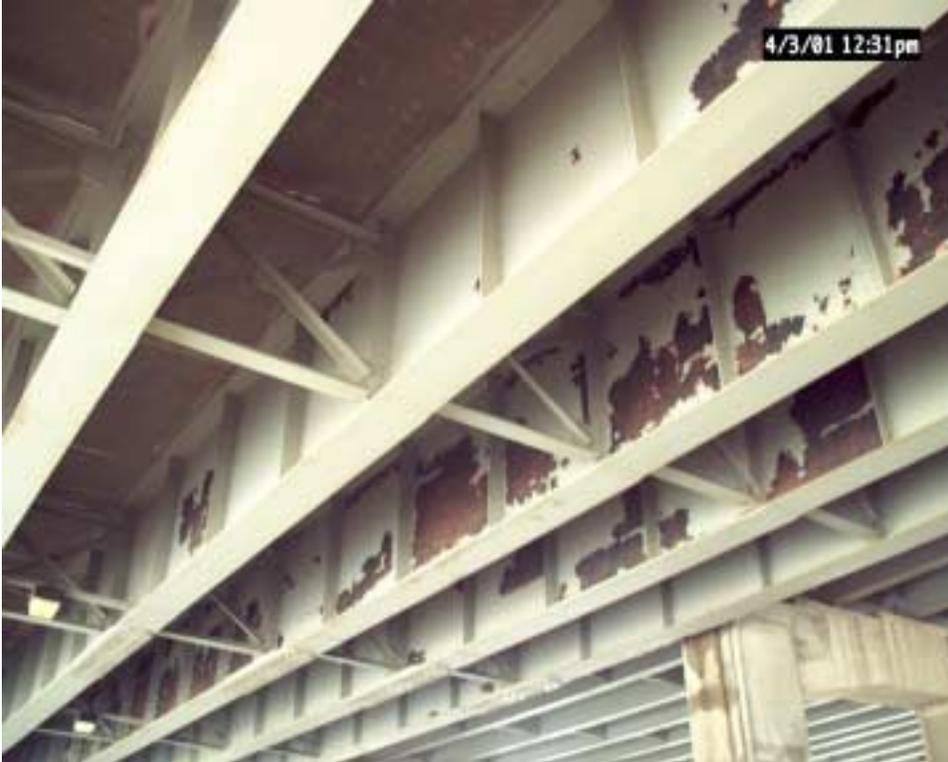
Figure 55. Bridge at Kentucky and Brook Streets before painting.

Figure 56. View of girders on bridge at Kentucky and Brook Streets before painting.

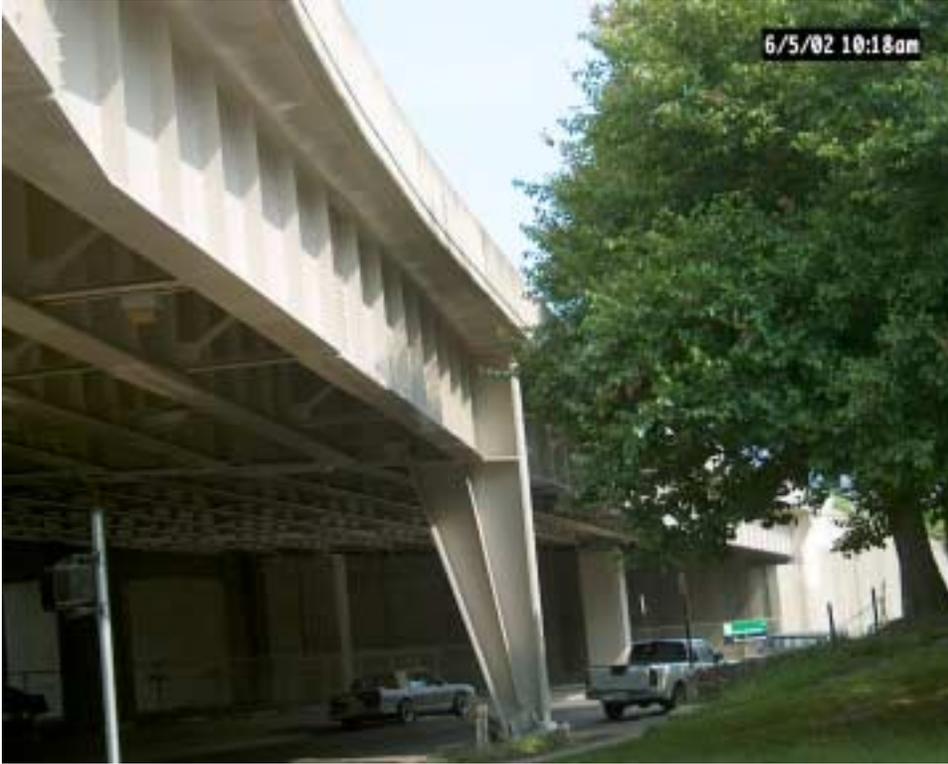
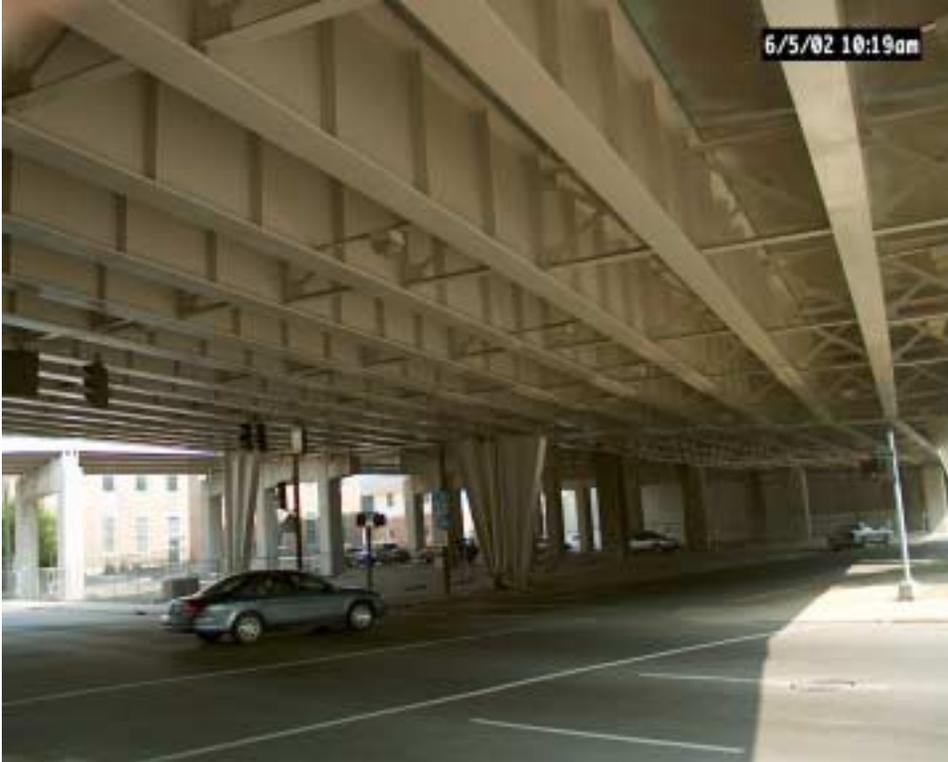
A final inspection was completed on September 28, 2001. The final inspection revealed that the bridge has cracking in the intermediate coat on the steel pier (upright) in one control area. The cracks were to be ground out so that the intermediate and finish coats could be reapplied. The bridge was found to be within conformance to the **Standard Specifications and Special Notes** of this project with the previous exceptions. Stenciling of the appropriate information is also needed. The work area was to be cleaned and all debris and waste removed from site. Personnel from KYTC Central Office Division of Construction and District 5, the Kentucky Transportation Center, and the contractor were present for that final inspection.

Figure 57. Bridge at Kentucky and Brook Streets after painting.

Figure 58. View of girders at Kentucky and Brook Street Bridge after painting.

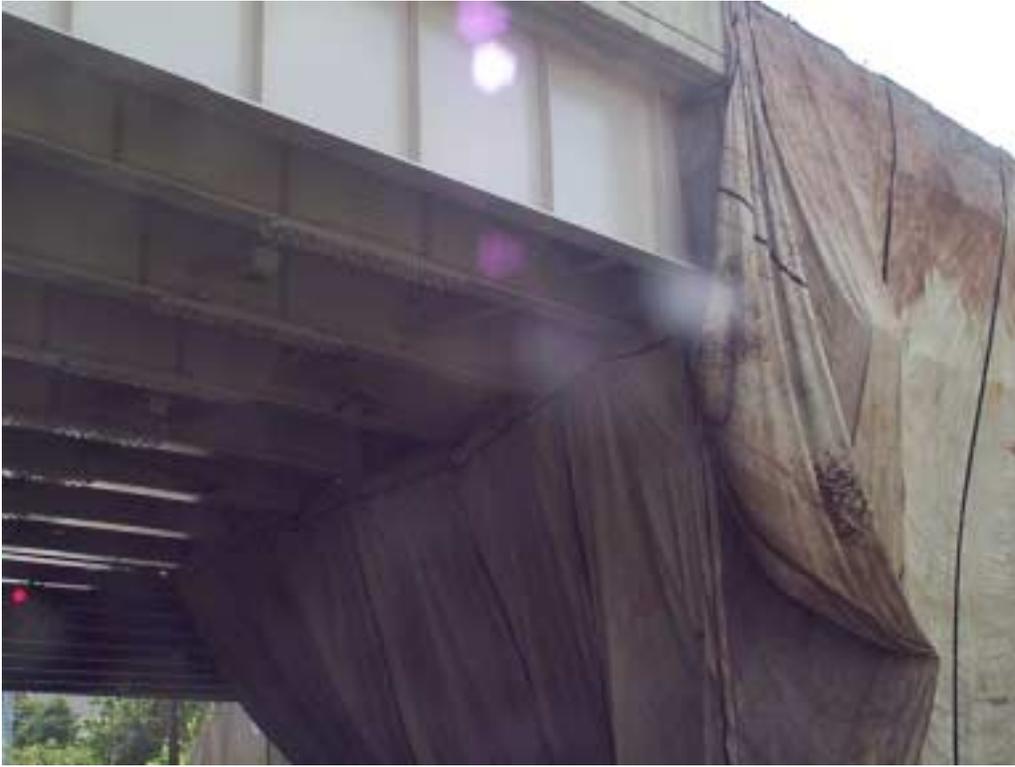
Figure 59. View of containment used at the Kentucky and Brook Street Bridge.

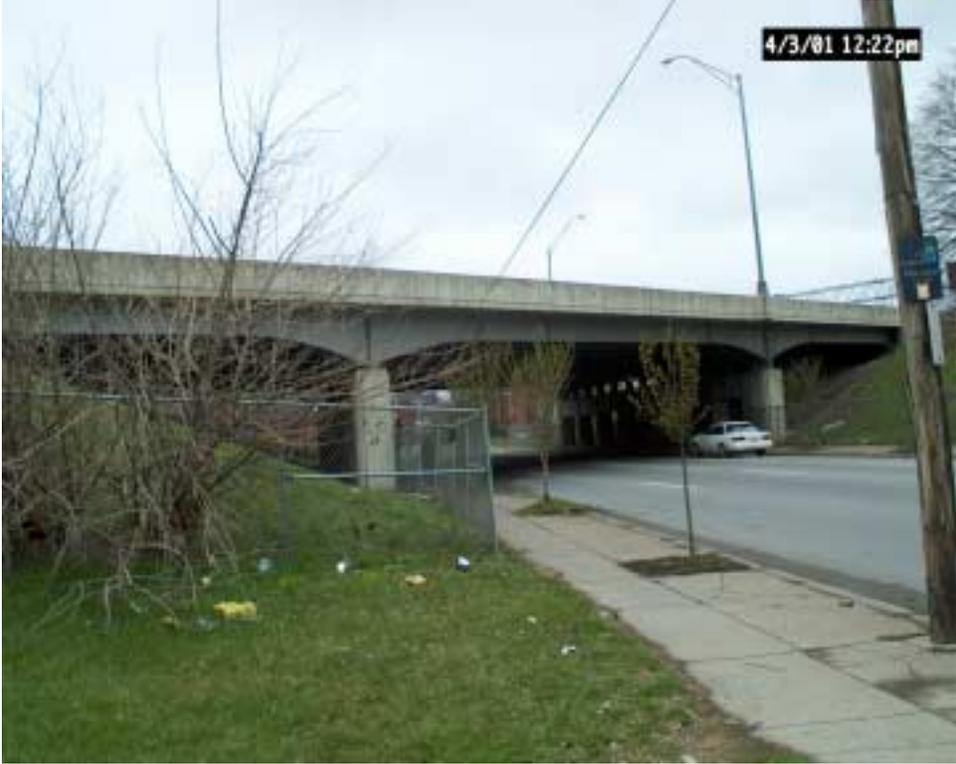
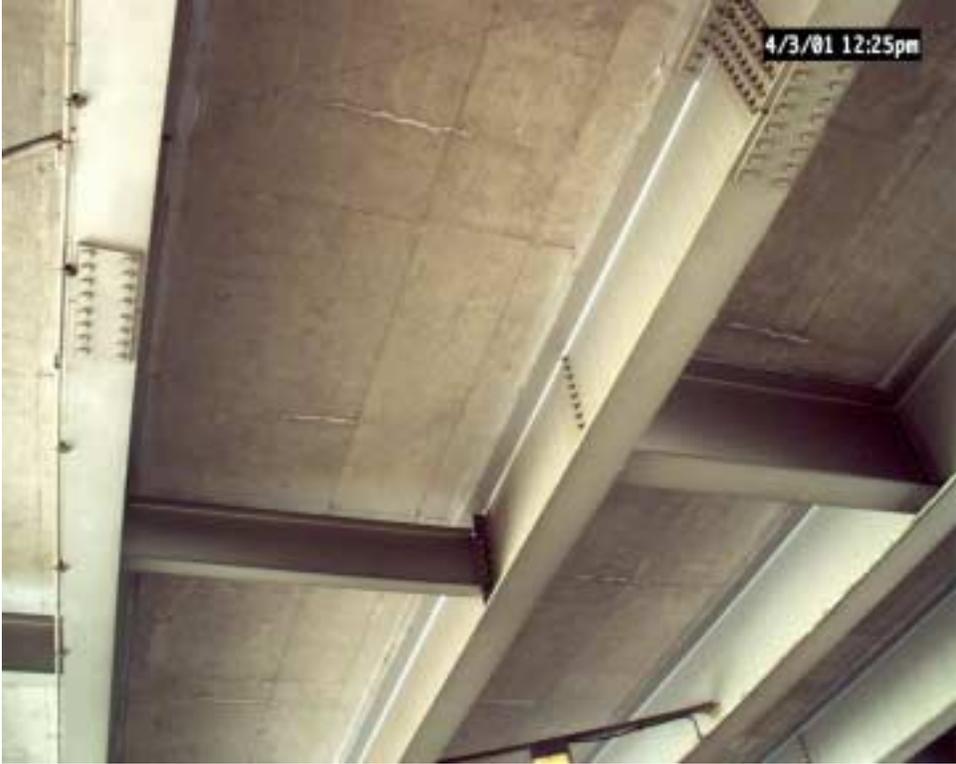
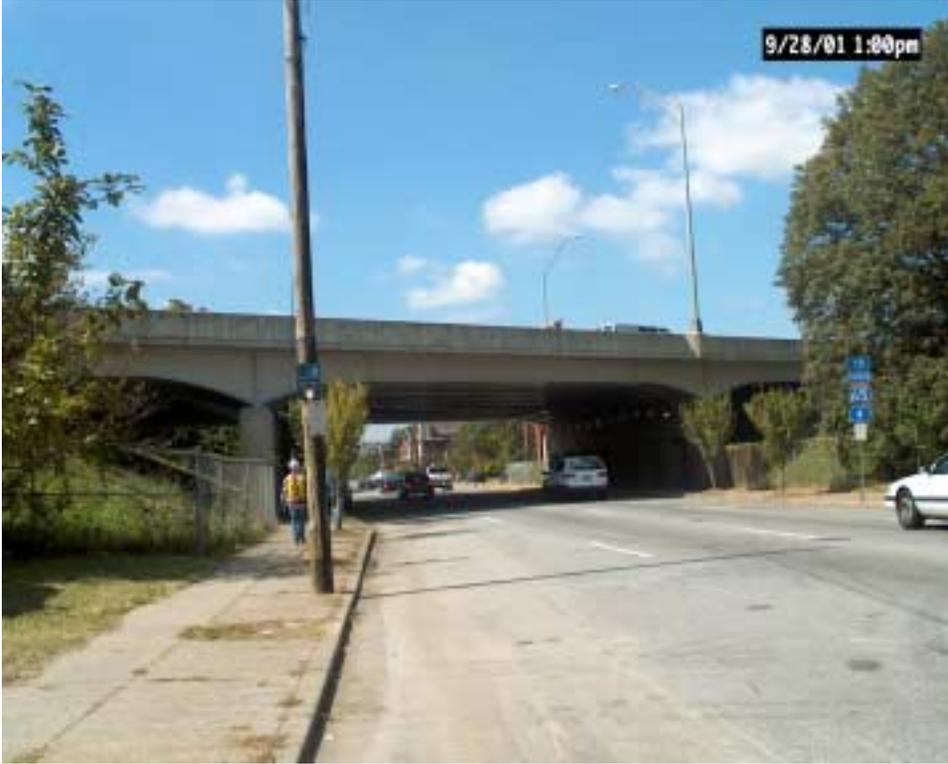
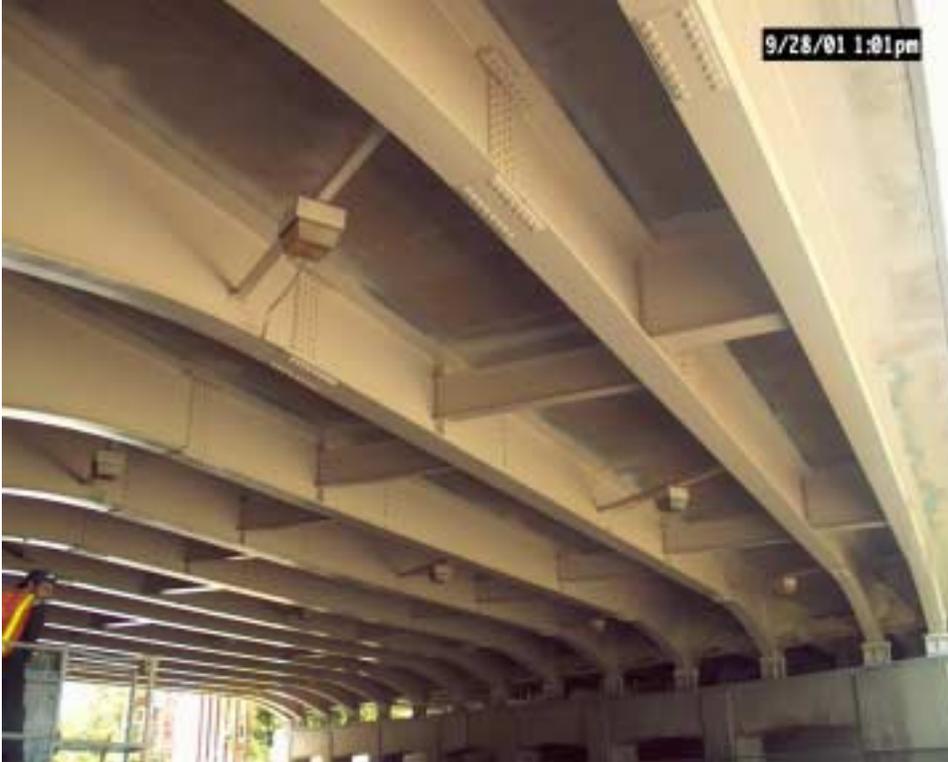
A final inspection was completed on September 28, 2001. The bridge was found to be within conformance to the **Standard Specifications and Special Notes** for this project. The work area was to be cleaned and all debris and waste removed from site. Personnel from KYTC Central Office Division of Construction and District 5, the Kentucky Transportation Center, and the contractor were present for that final inspection.

Figure 60. Bridge at St. Catherine Street before painting.

Figure 61. View of girders at the St. Catherine Street Bridge before painting.

Figure 62. View of bridge at St. Catherine Street after painting.

Figure 63. View of girders at St. Catherine Street Bridge after painting.

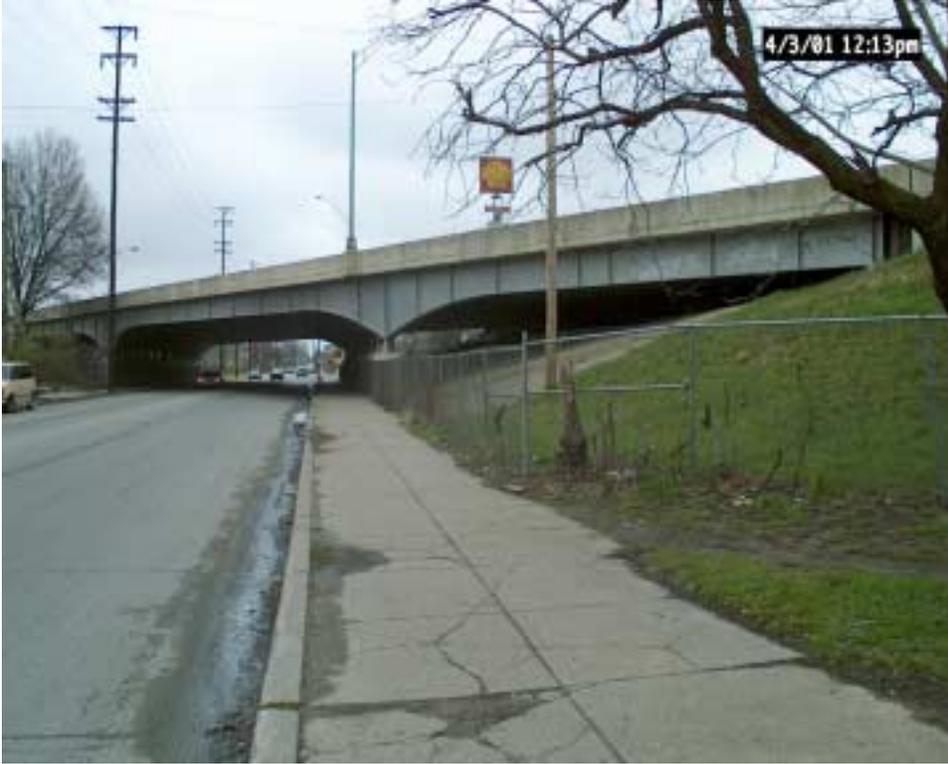
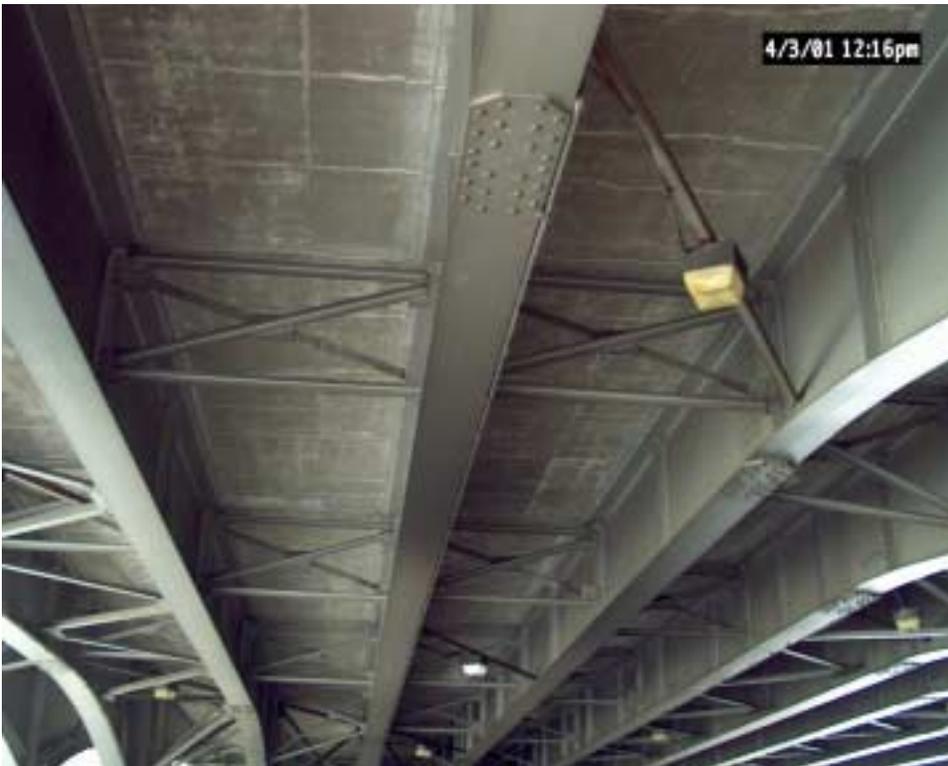
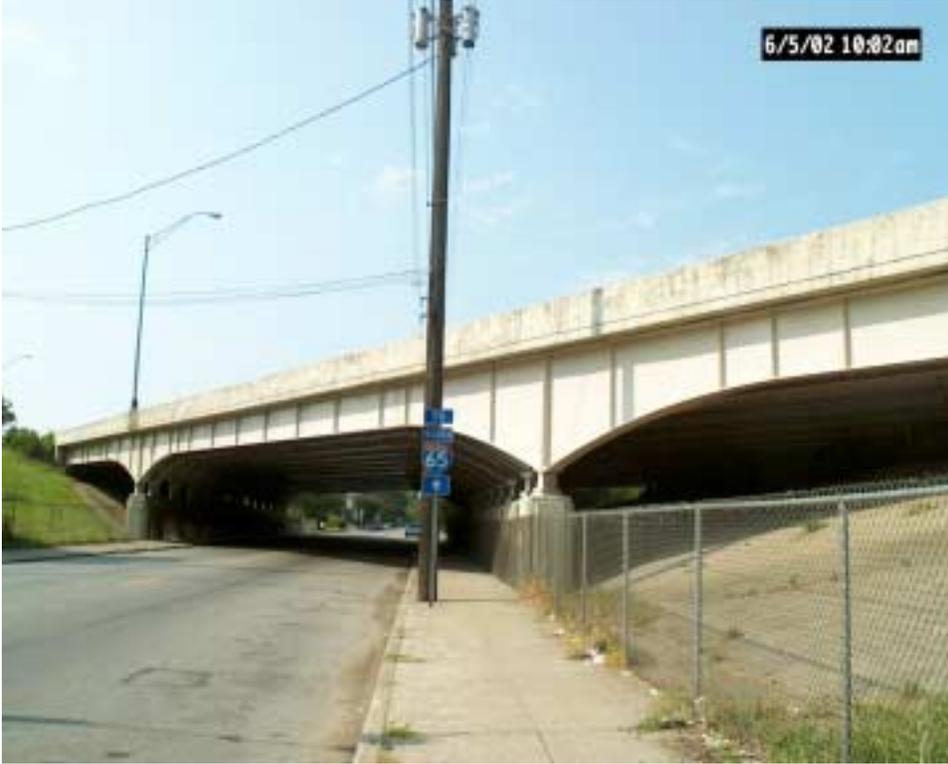
A final inspection was completed on September 12, 2001. The bridge was found to be within conformance to the **Standard Specifications and Special Notes** of this project with the following exceptions. Holidays and missed spots needed to be repaired by applying finish coat to those areas. Also, touch up was required where the rigging had been removed. The work area was to be cleaned and all debris and waste removed from site. Personnel from KYTC Central Office Division of Construction and District 5, the Kentucky Transportation Center, and the contractor were present for that final inspection.

Figure 64. View of bridge at Floyd Street, North of Oak before painting.

Figure 65. Girders at Floyd Street Bridge, North of Oak before painting.

Figure 66. View of bridge at Floyd Street, North of Oak after painting.

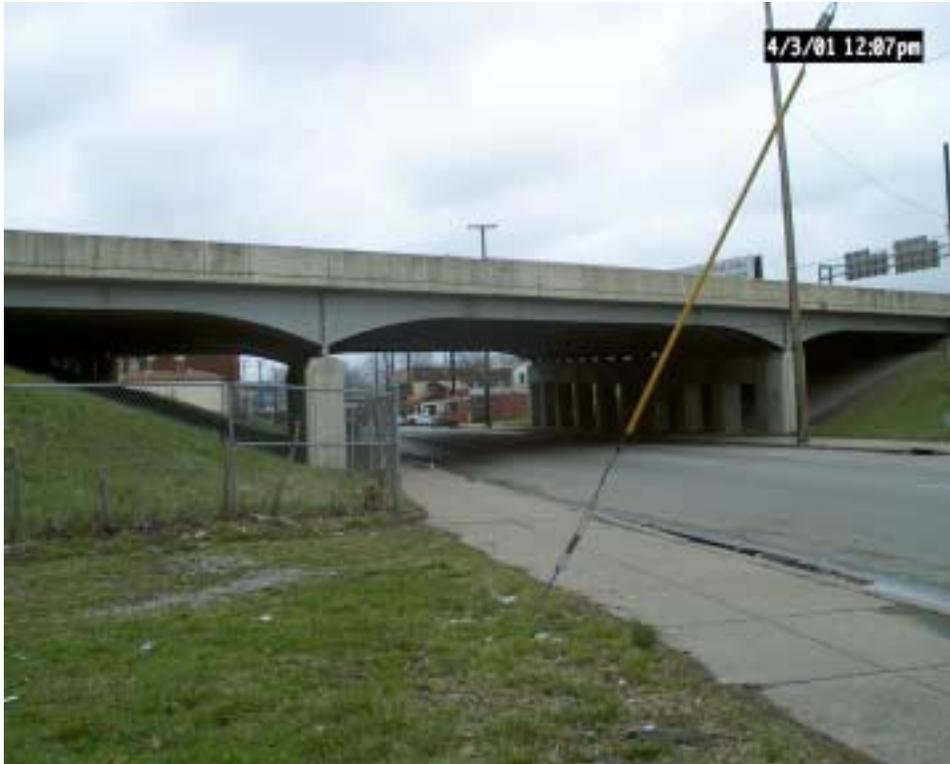
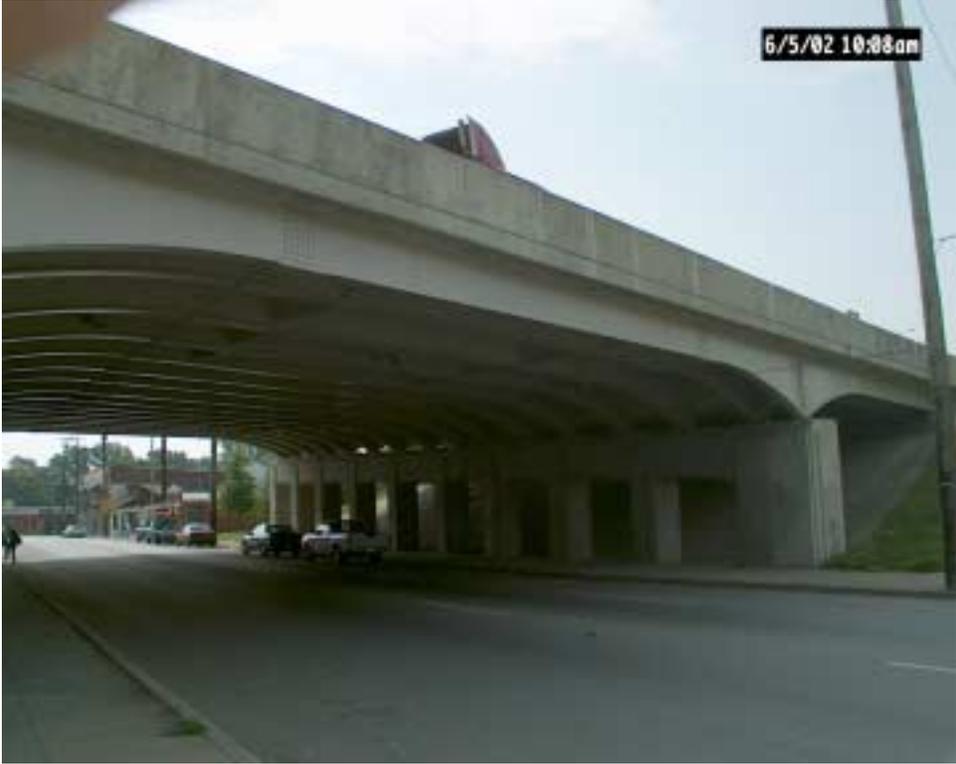
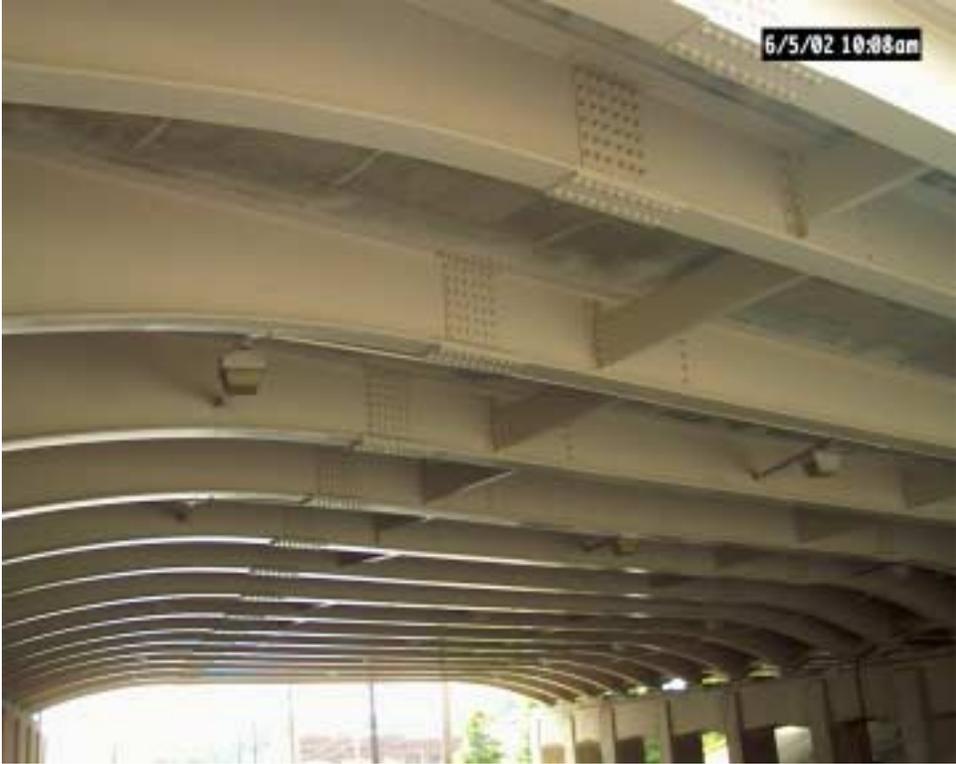
A final inspection was completed on November 2, 2001. The bridge was found to be within conformance to the **Standard Specifications and Special Notes** of this project with the following exceptions. In some control areas, cracks in the intermediate coat around the bolt patterns and rockers needed repairing by grinding and reapplying coatings to proper DFT. The touch up of holidays and lights spots was also needed. The work area was to be cleaned and all debris and waste removed from site. Personnel from KYTC Central Office Division of Construction and District 5, the Kentucky Transportation Center, and the contractor were present for that final inspection.

Figure 67. View of bridge at Oak Street before painting.

Figure 68. Girders on bridge at Oak Street before painting.

Figure 69. Bridge at Oak Street after painting.

Figure 70. View of girders at bridge on Oak Street after painting.

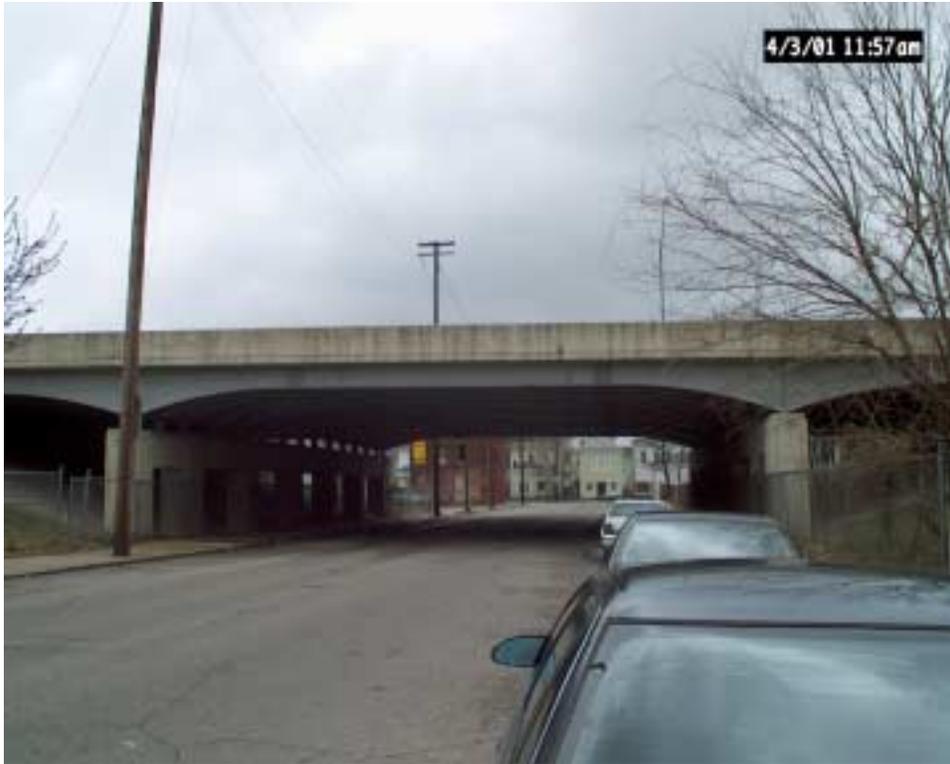
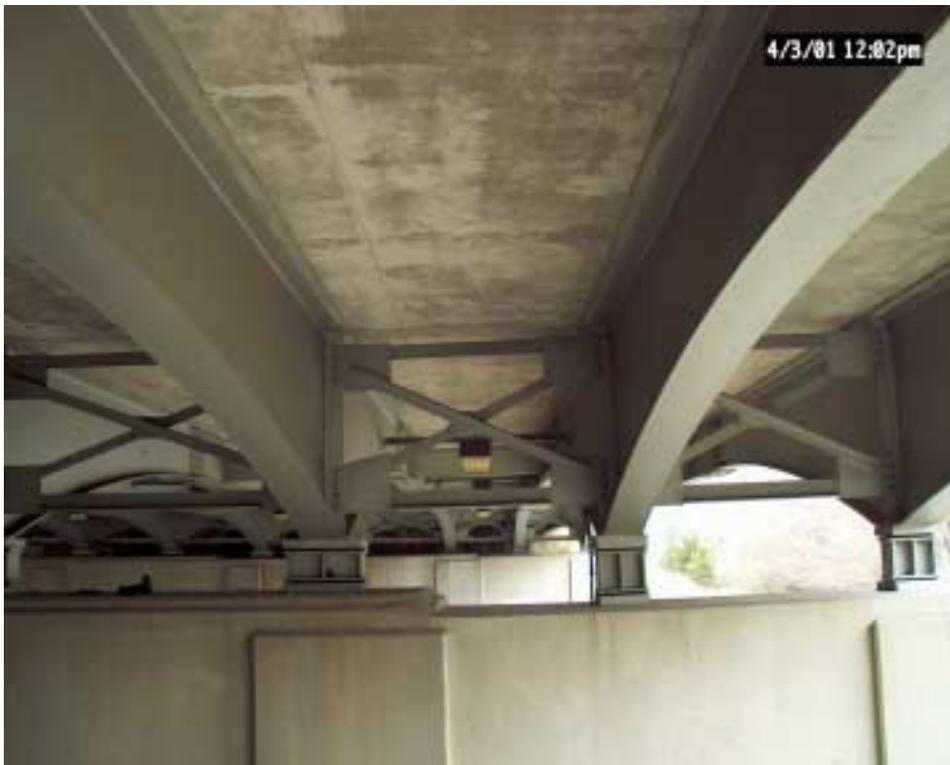
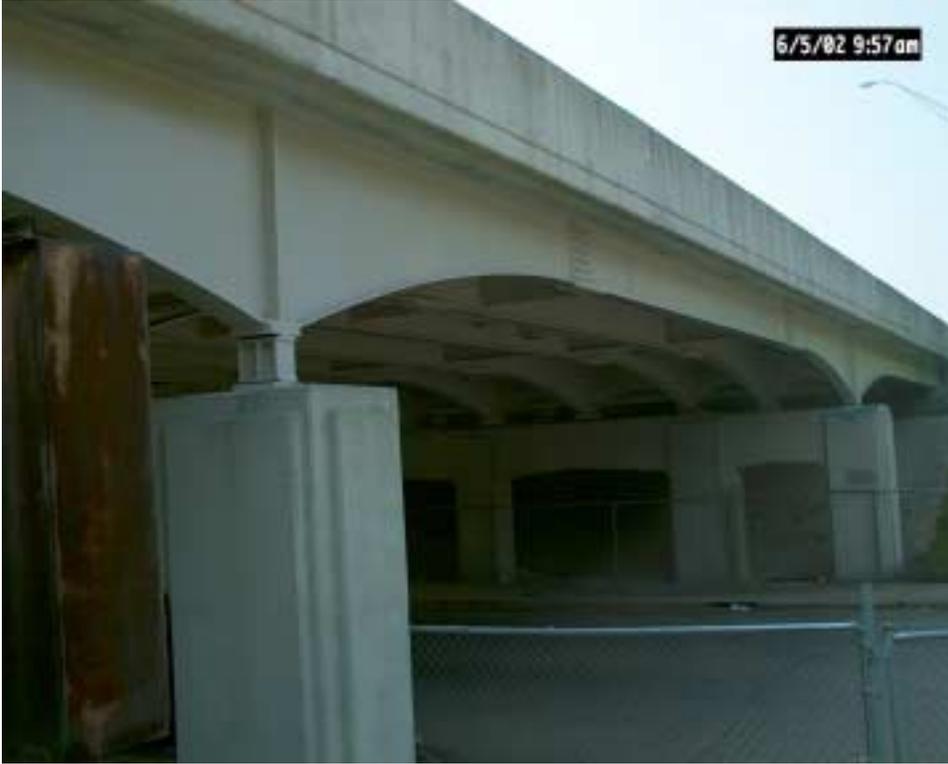
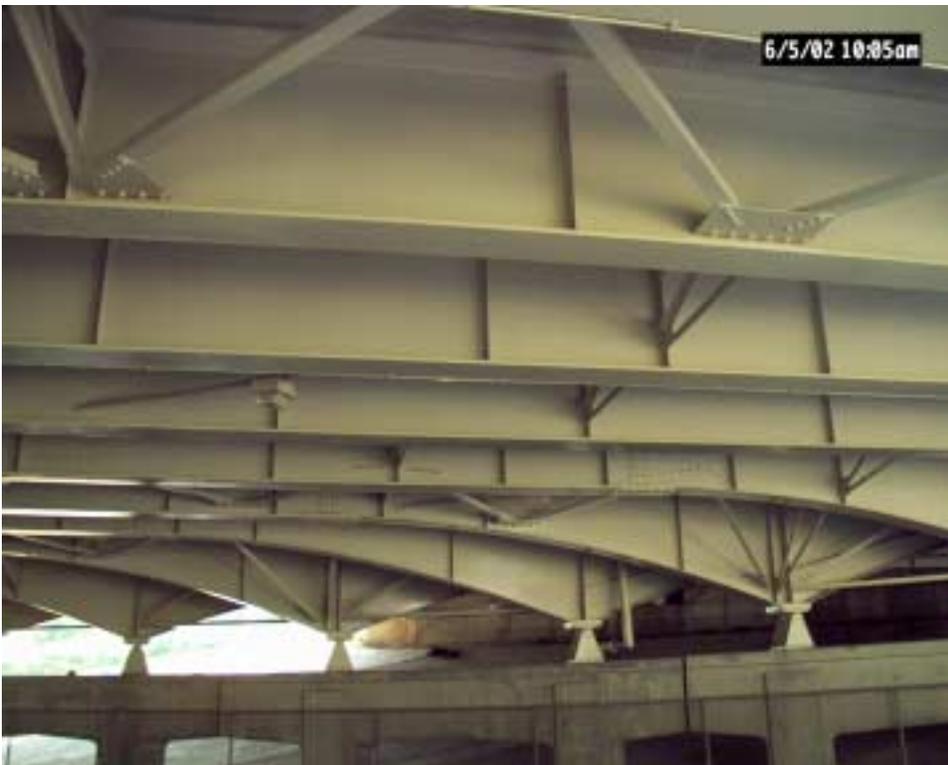
A final inspection was completed on September 28, 2001. The bridge was found to be within conformance to the **Standard Specifications and Special Notes** of this project with the following exceptions. Over Ormsby Street, two areas of significant run in the finish coat were found. Runs were to be repaired by grinding or sanding smooth and reapplying the topcoat. The work area was to be cleaned and all debris and waste removed from site. Personnel from KYTC Central Office Division of Construction and District 5, the Kentucky Transportation Center, and the contractor were present for that final inspection.

Figure 71. Bridge at Ormsby Ave. before painting.

Figure 72. View of girders on bridge at Ormsby Ave before painting.

Figure 73. View of bridge at Ormsby Ave. after painting.

Figure 74. View of girders on bridge at Ormsby Ave. after painting.

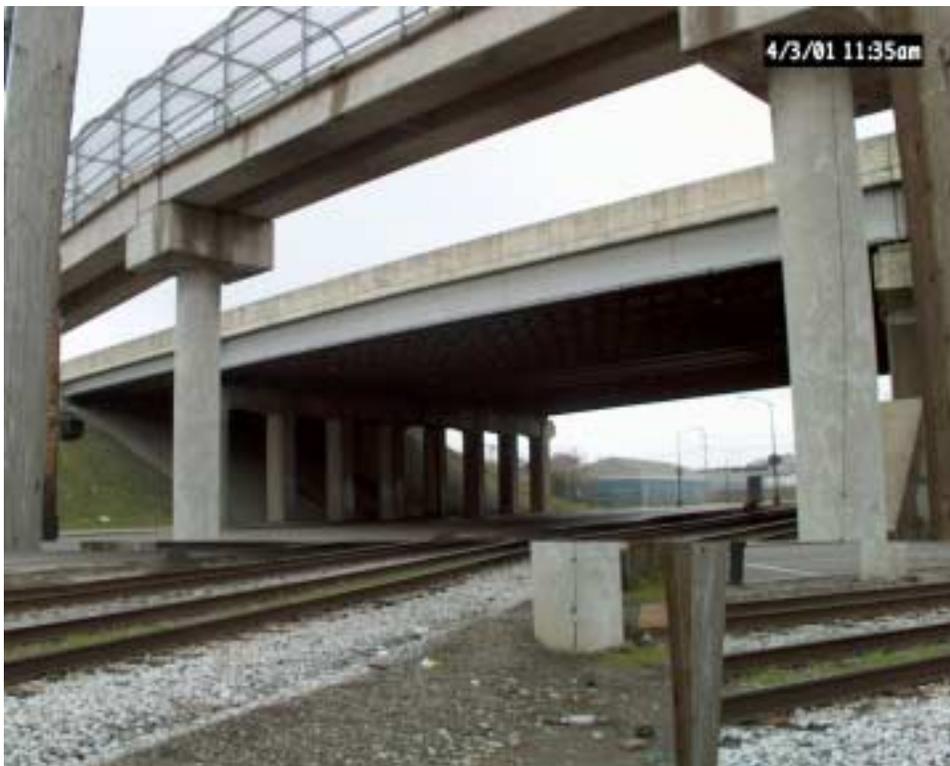
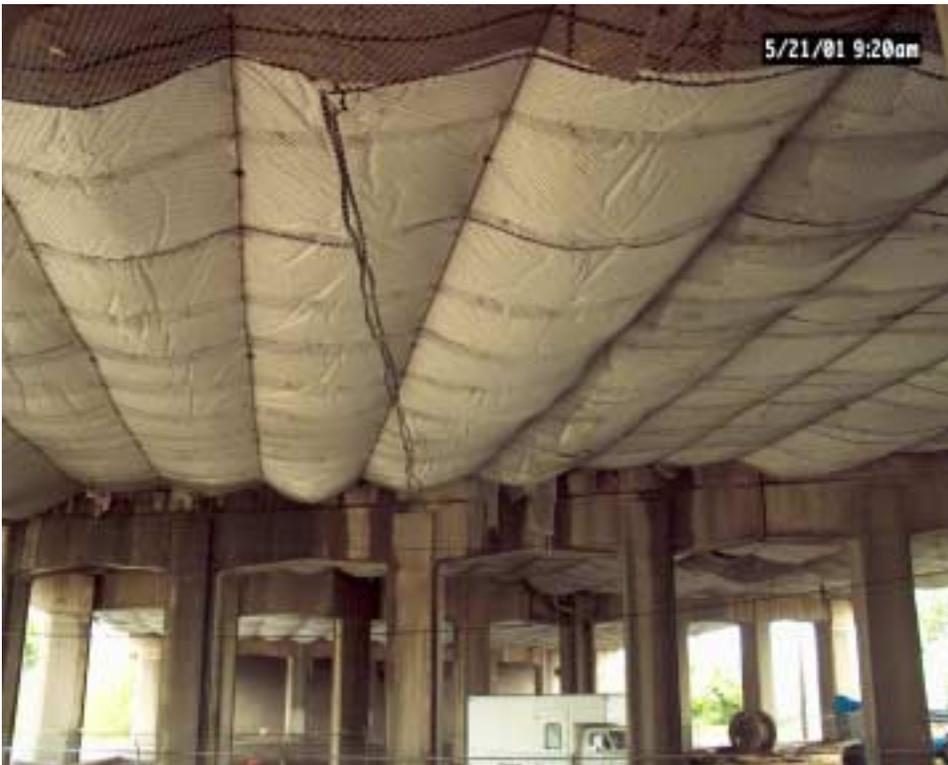
Figure 76. View of the bridge at Burnett and Hill Street over the railroad before painting.

Figure 78. View of containment at the Burnett and Hill Street Bridge during painting.

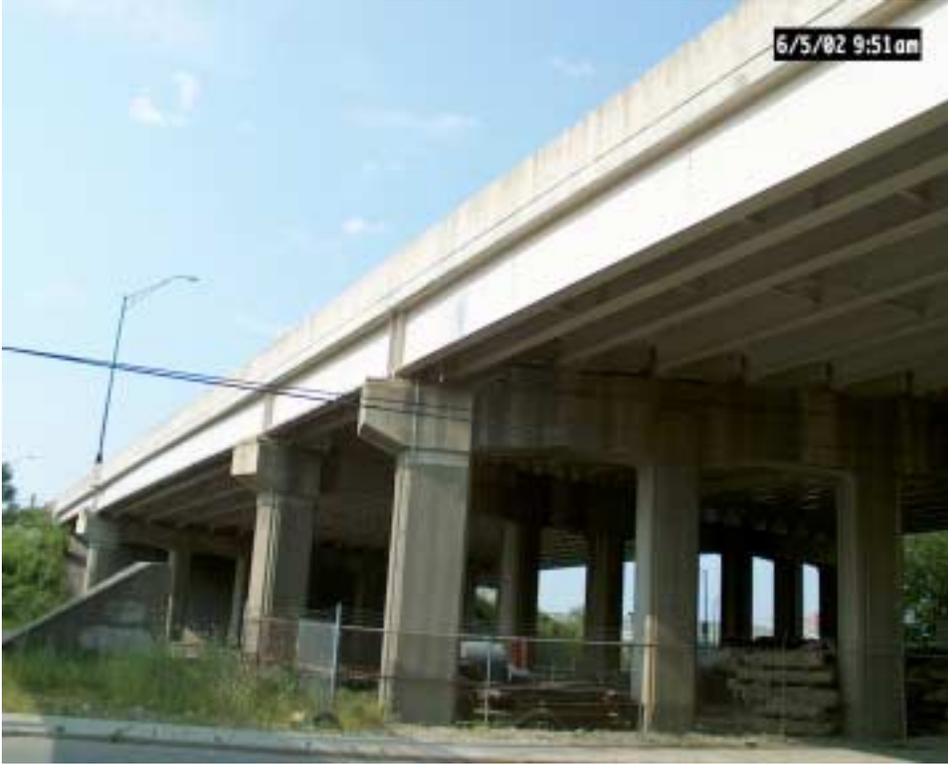
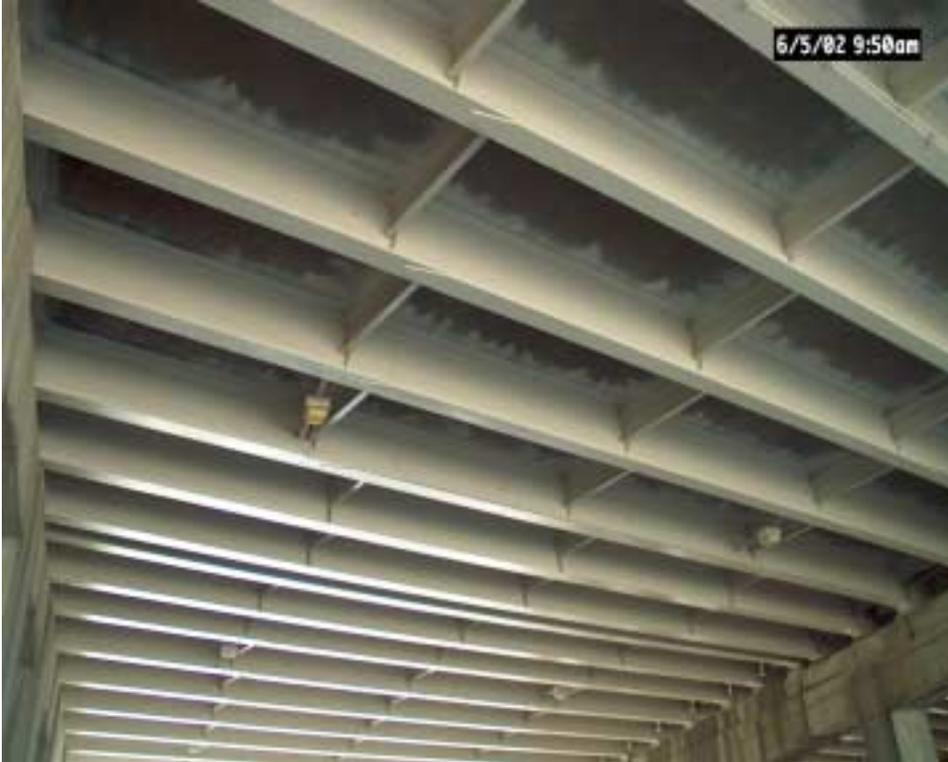
A final inspection was completed on June 28, 2001 for four of the five spans. At this point, the middle span had yet to be painted. The bridge was found to be within conformance to the **Standard Specifications and Special Notes** of this project. Contractor was directed to repair misses on the diaphragms and finish touch up work to complete this bridge.

Figure 79. View of bridge at Burnett and Hill Street after painting.

Figure 80. View of girders at Burnett and Hill Street Bridge after painting.
